HOUSATONIC RIVER BASIN
LENOX, MASSACHUSETTS

UPPER ROOT RESERVOIR DAM
MA 00019

PHASE I INSPECTION REPORT
NATIONAL DAM INSPECTION PROGRAM

MARCH, 1981

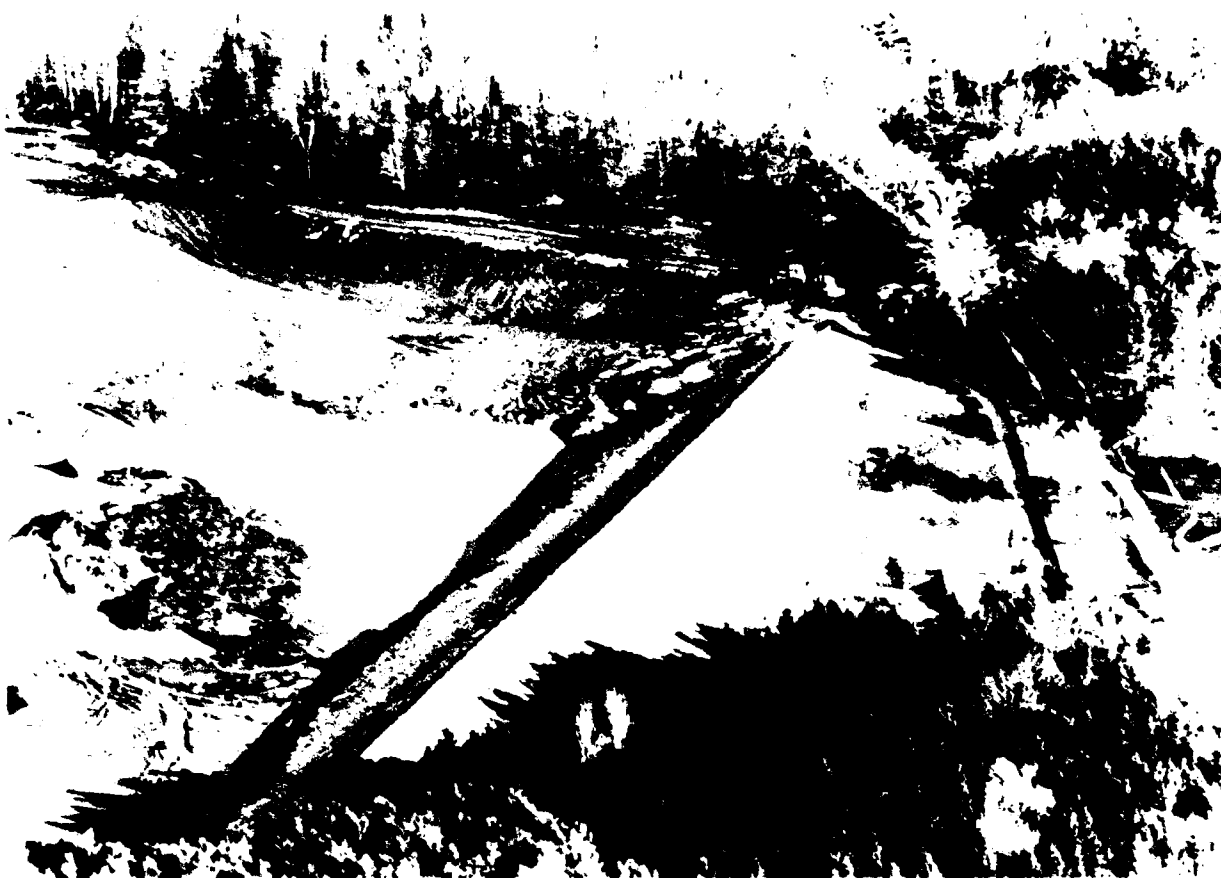
OVERVIEW OF UPPER ROOT RESERVOIR DAM

There are areas of anomalous vegetation (see Overview Photograph) on the downstream slope which should be monitored for wetness after the reservoir is filled. A couple of small (4 to 6-inch) active animal burrows were noted on the downstream slope.

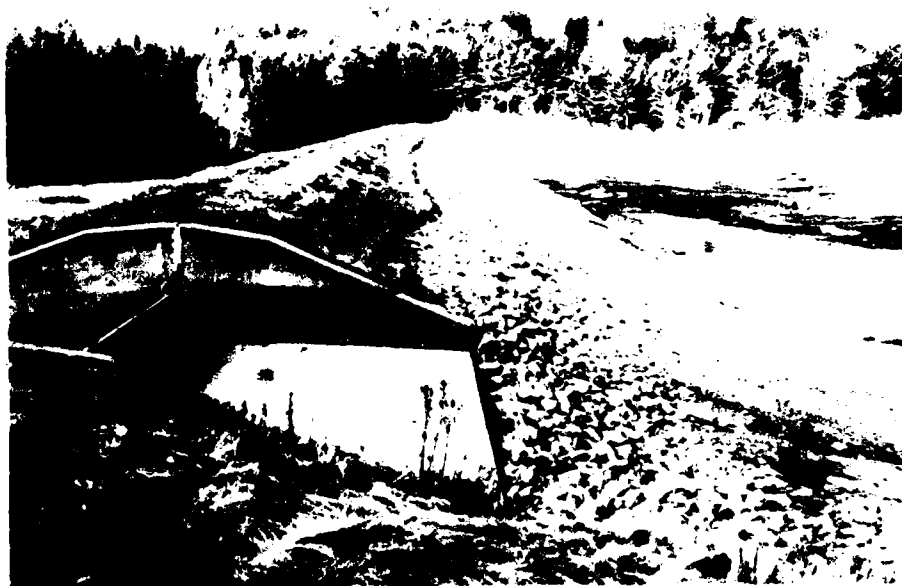
The riprap on the upstream face overall is in good condition except that there is an area to the west of the dam center where the riprap surface appears warped, possibly as a result of down-slope creep. The warped area is about 40 feet by 75 feet. The top of riprap is approximately at the same elevation as the top of flashboards and there is a wave bench above the riprap where the water has undercut the embankment crest by up to about 12 inches during times when the water level is at or above the top of flashboards (see Photograph 2, Appendix C).

The approach channel for the spillway is satisfactory with no obstructions noted. The riprap floor for spillway approach is about 1 foot lower than the concrete spillway crest (see Photograph 2, Appendix C). The riprap should be graded up to the concrete to form a smoother transition at this point.

Photograph 2 - Upstream slope, crest and spillway approach looking west. Note level of water mark in relationship to top of riprap elevation.

- Design methods to extend the slope protection to a higher elevation on the upstream slope in order to halt undercutting of the crest.
- Investigate the condition and adequacy of the existing toe drainage system, particularly in light of recent construction activity in this area.

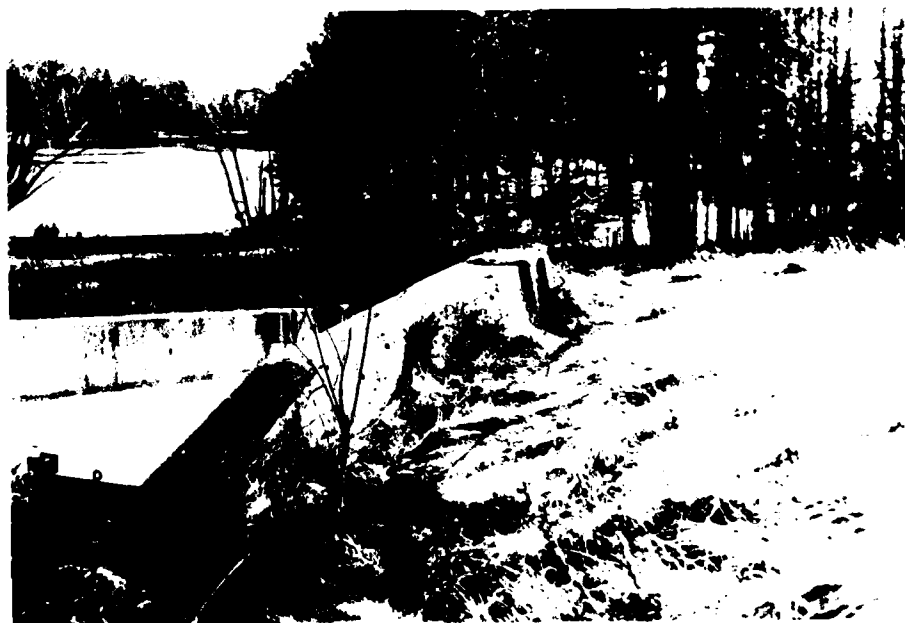
Photograph 12 - Typical low area behind spillway walls. Areas are approximately 1 foot lower than the top of dam. There are no cutoffs or projections of the spillway walls.

- Design repairs to restore the crest elevation to a uniform grade, particularly low areas adjacent to the spillway walls. Repairs of wheel ruts on the downstream should be designed.

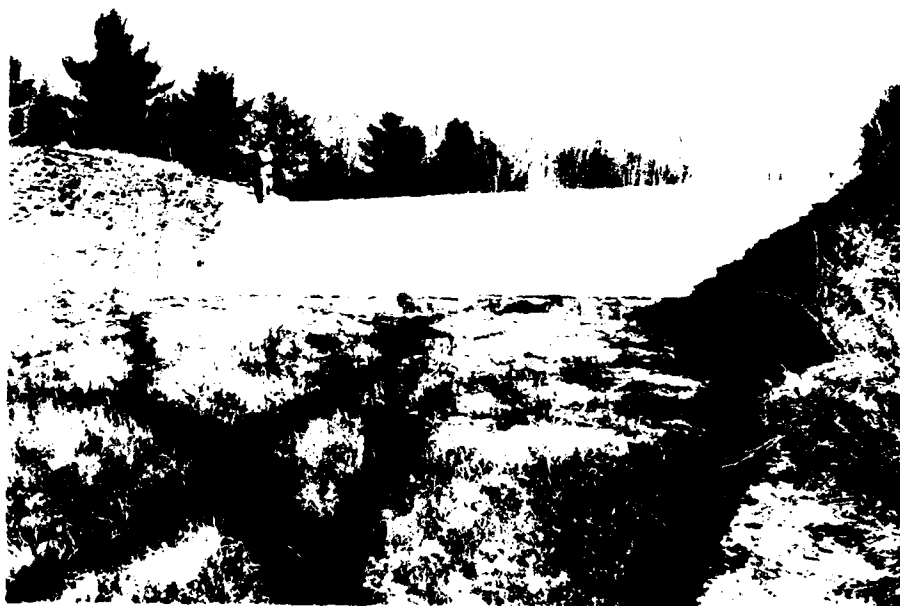
Photograph 17 - View of spillway (looking upstream) for Lower Root Reservoir Dam.
